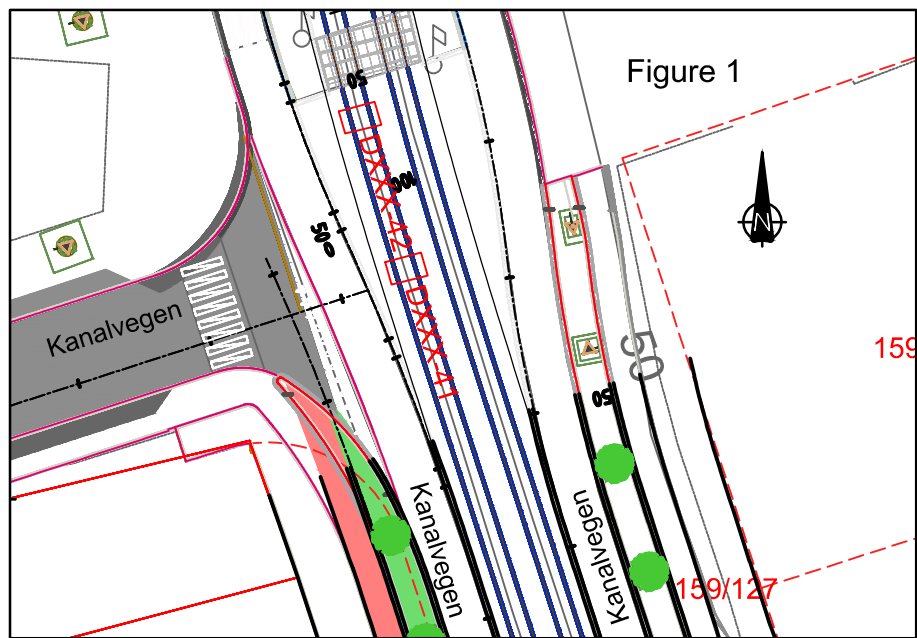
Call detectors were added to the

- exit of Mindemyren station for northbound rail traffic (Figure 2)
- after the pedestrian crossing located at the south side of the study area for southbound rail traffic (Figure 1).
